ERL主加速部#4号機 縦測定結果の報告

2011/12/2

ERL検討会

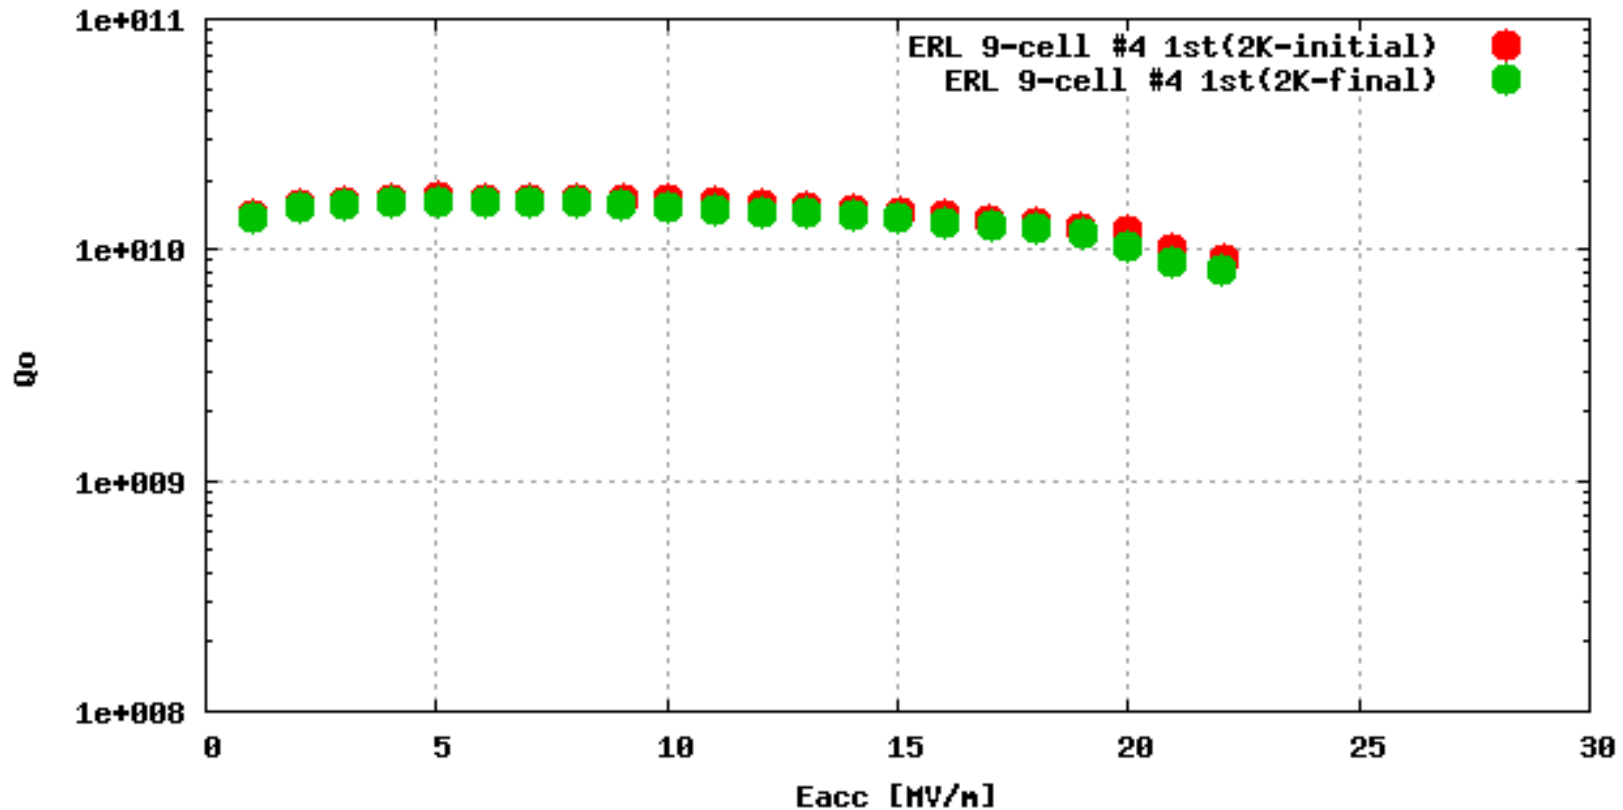
#4 cavity 1st vertical test (10/27)

- Initial (1.6-1.8K), Passband(8pi), Final (1.7-1.8K)
- Max. Field 22.7 MV/m, quench at 1 cell equator
- $Q=1.4 \times 10^{10}$ (@15MV/m), 1.0×10^{10} (@20MV/m)
- X-ray on set: (initial) 18MV/m \rightarrow (final) 15MV/m
- X-ray at 20 MV/m: (initial) 3.7uSv/h \rightarrow (final) 644 uSv/h

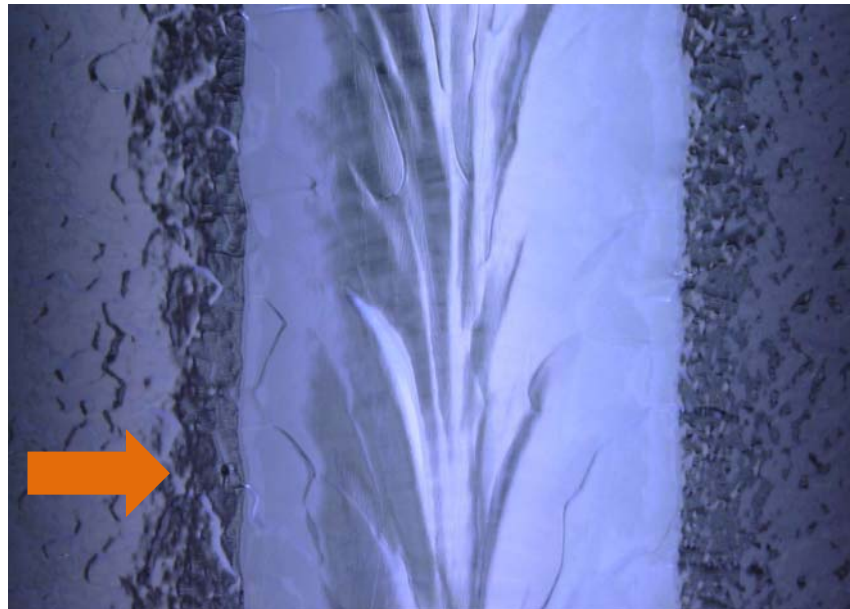
① 1 cell equator 264 deg(=224 for mapping)

After 1st vertical test

Defect was found after vertical test

Bump

Height ~10um

Width ~200um

Local grinding

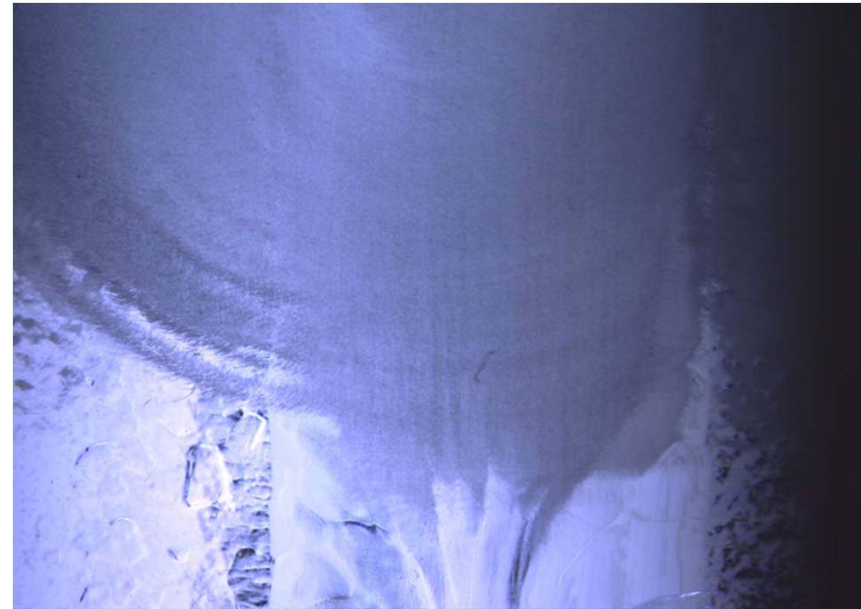
Defect disappeared after local grinding

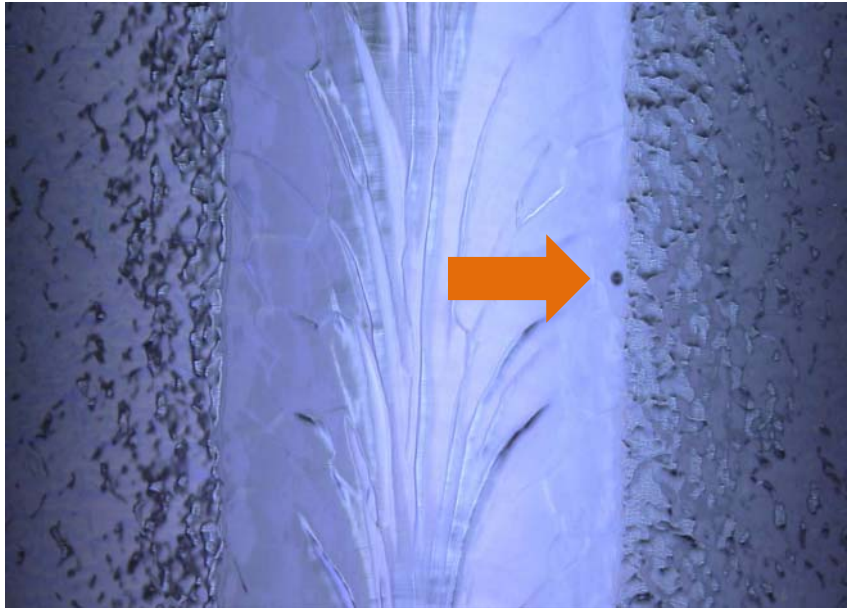
② 8 cell equator 194 deg

After 1st vertical test

Defect was found after vertical test

Pit

Height ~10um

Width ~150um

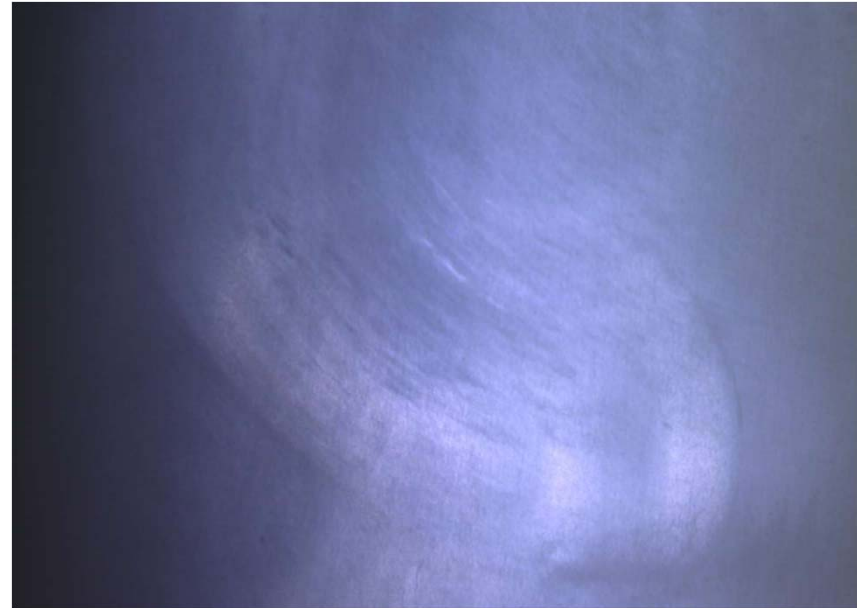
After local grinding

Defect disappeared after local grinding

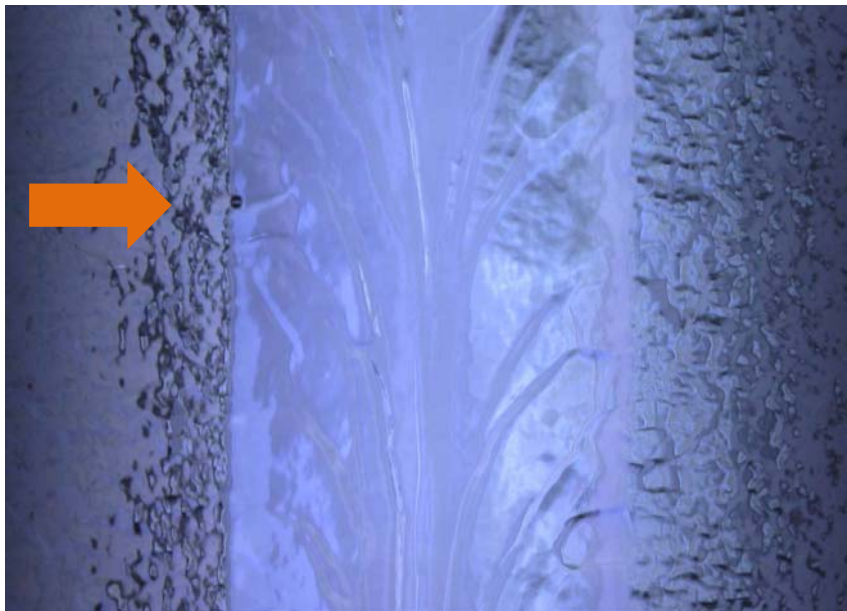
③ 9 cell equator 102 deg

After vertical test

Defect was found after vertical test

Pit

Height 15~20um

Width ~200um

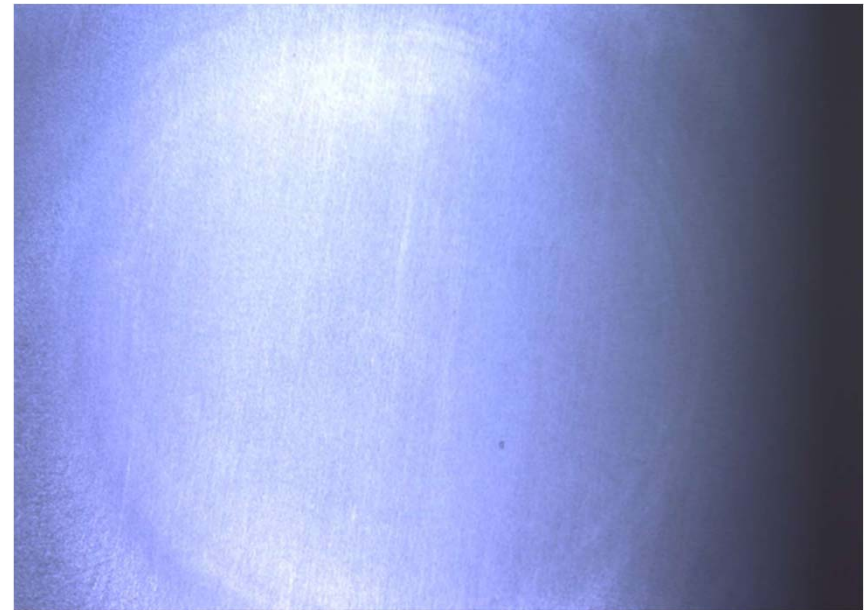
After local grinding

Defect disappeared after local grinding

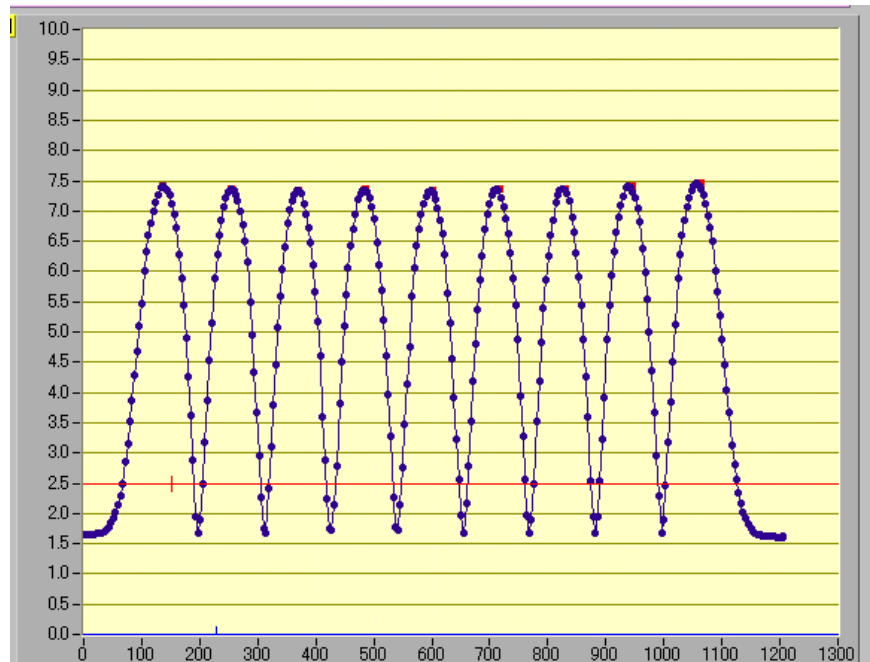
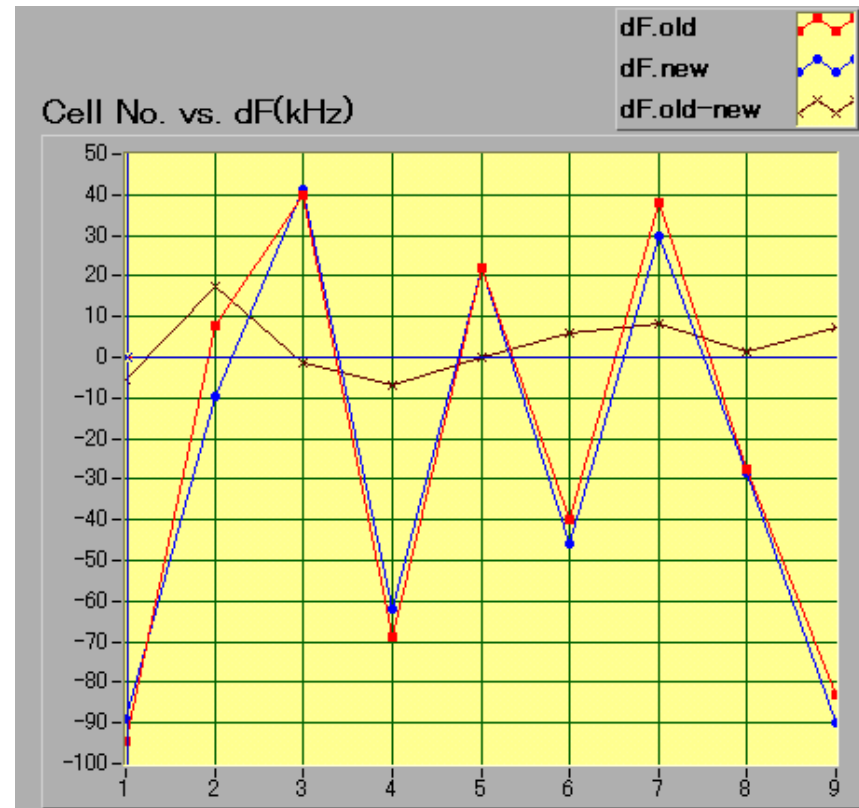
Pre-tuning

Field flatness 98.5%

Frequencies of both end cells are $\sim 100\text{kHz}$ higher than those of center cells
→ should be better flatness after EP-2(30 μm)

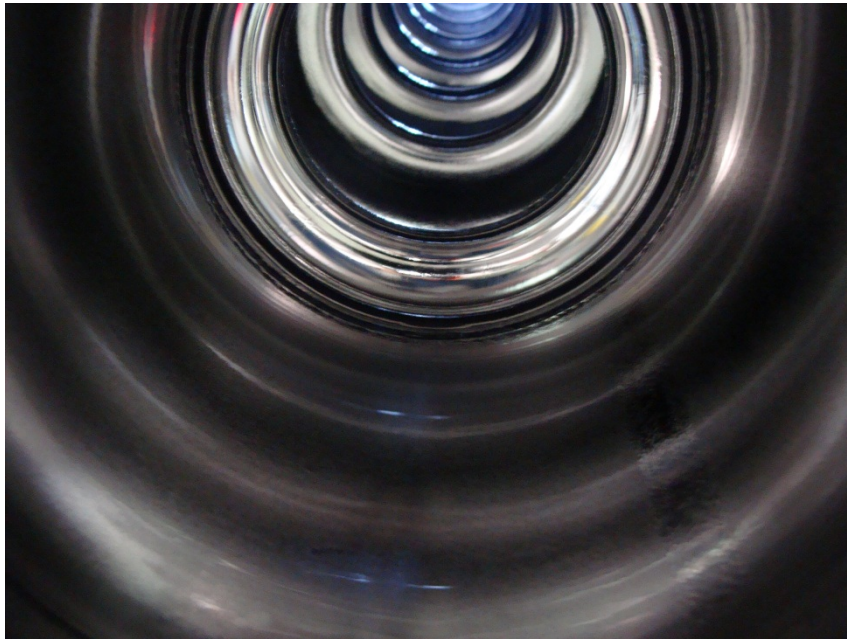
From LBP side

Cavity surface is generally fine.
Some defects, polished after EP-1 were seen. But edges seem to be smooth.

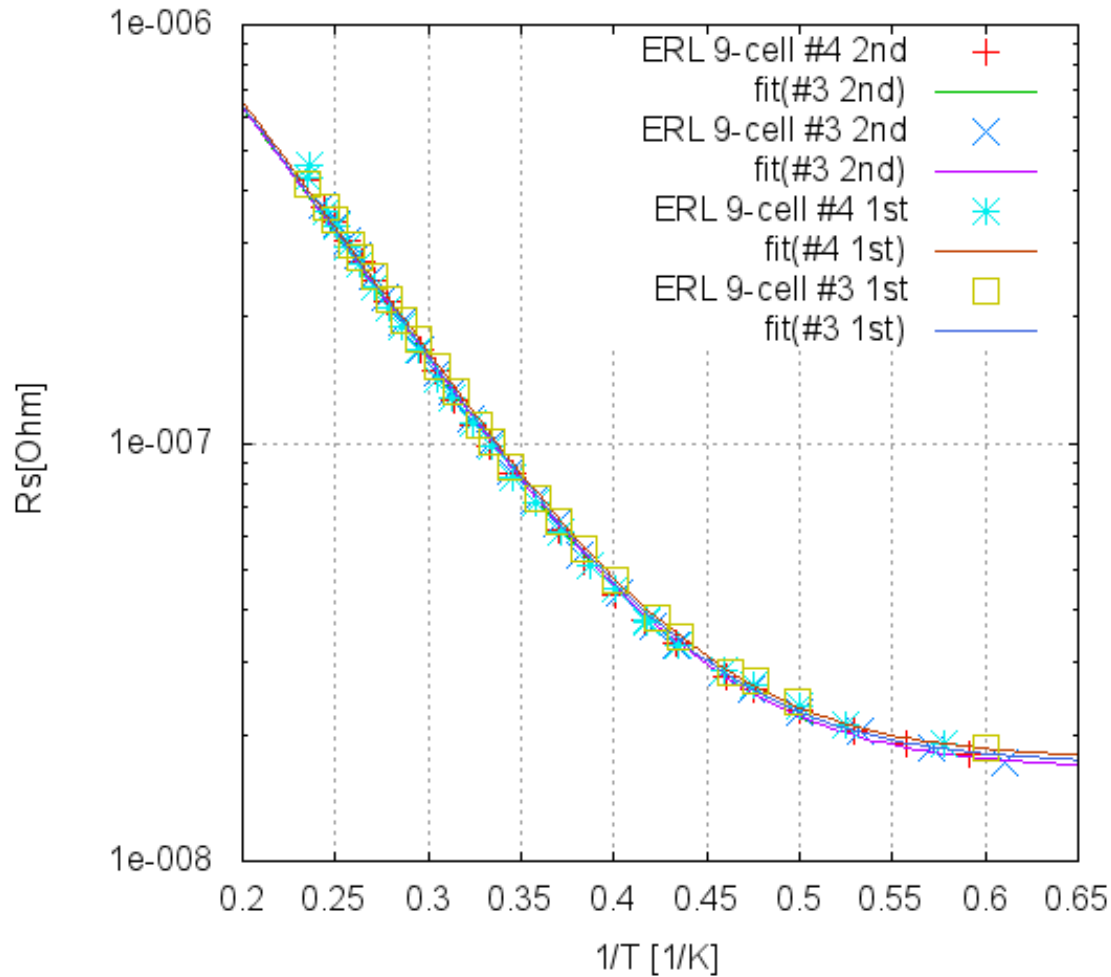
Q-T curve for ERL 9-cell #3 and #4 cavity

#3 cavity (1st VT)
1299.647 MHz(@2K)
17.5 nΩ

#3 cavity (2nd VT)
1299.603 MHz(@2K)
16.6 nΩ

#4 cavity (1st VT)
1299.717 MHz(@2K)
17.0 nΩ

#4 cavity (2nd VT)
1299.640 MHz(@2K)
16.6 nΩ

Residual resistance
Includes loss at SUS
flanges

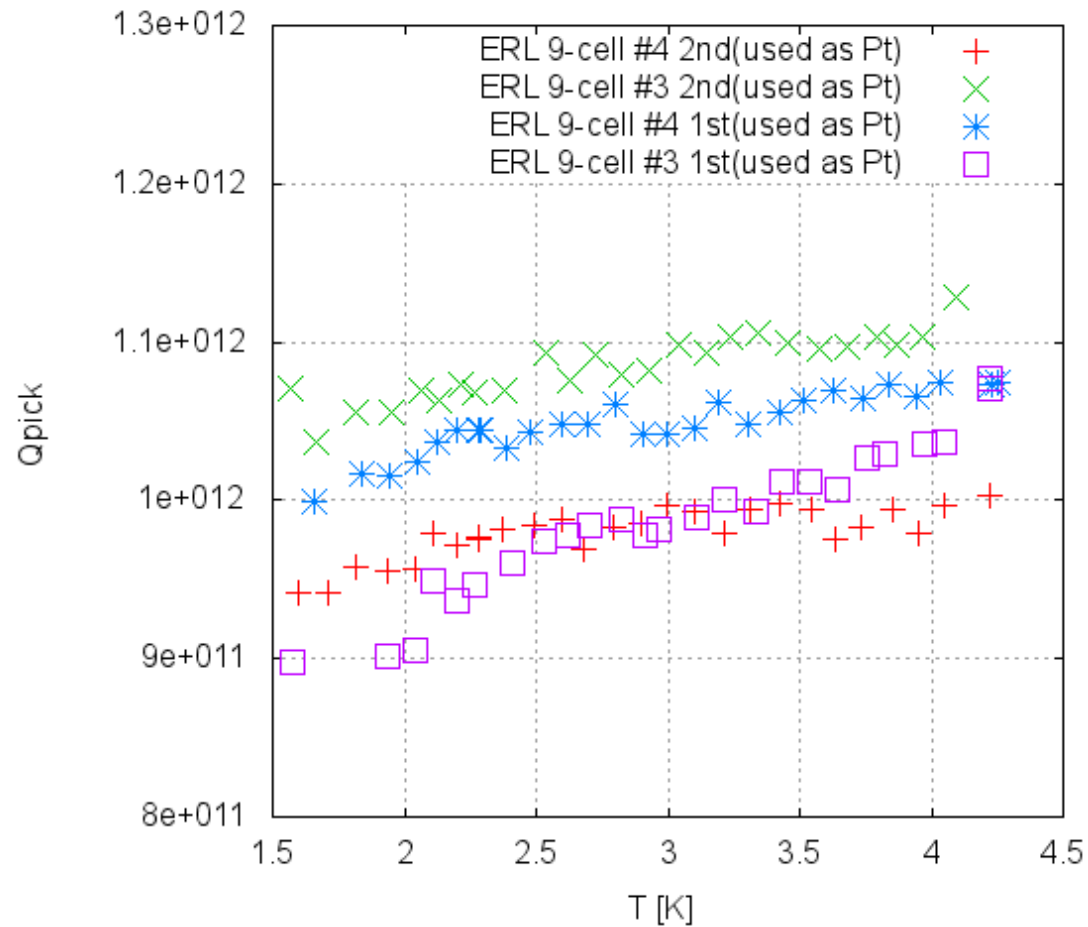
Qpickup for #3 and #4 cavities

Target of Q_{pickup} $1e12$

Q_{pickup} at 2K is OK, within 5~10%.

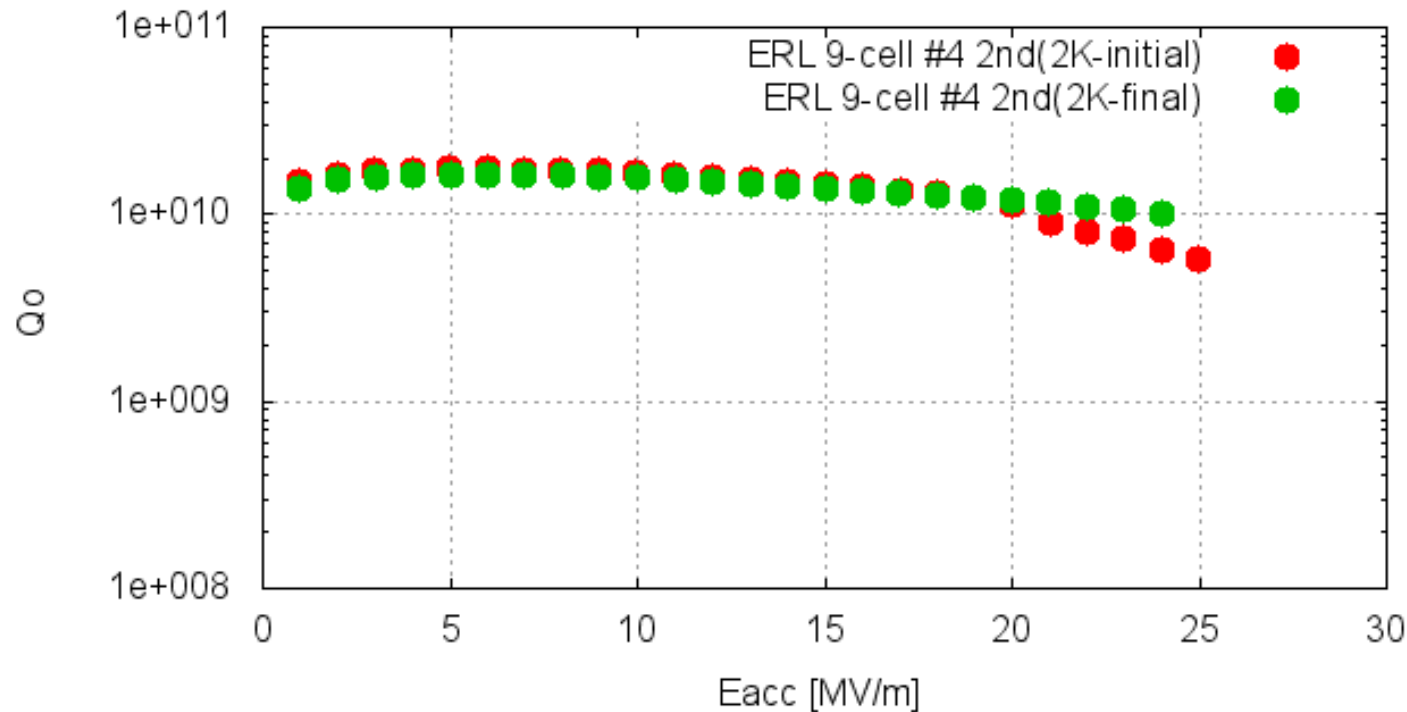
2K π -mode measurement

- Initial (1.6-2.1K), Final (1.7-1.8K)
 - At 3MV/m, $Q_0=1.5e10$ (1.8K) and $Q_0=1.1e10$ (2.1K)
- Reached to 25 MV/m. Satisfied ERL spec.
- 1.4×10^{10} (@15MV/m), 1.2×10^{10} (@20MV/m)
- No limitation up to 25MV/m

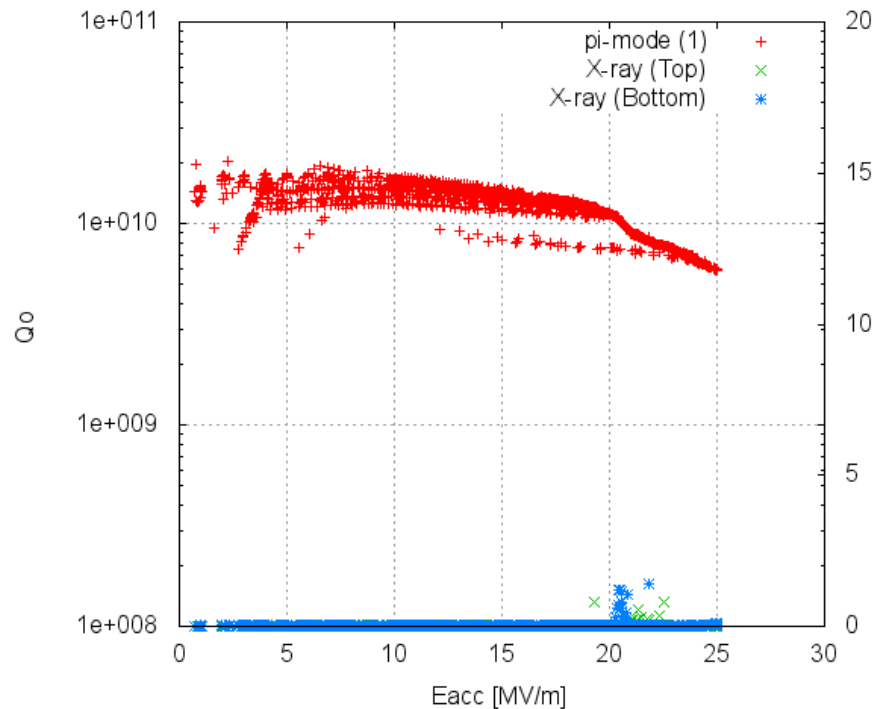
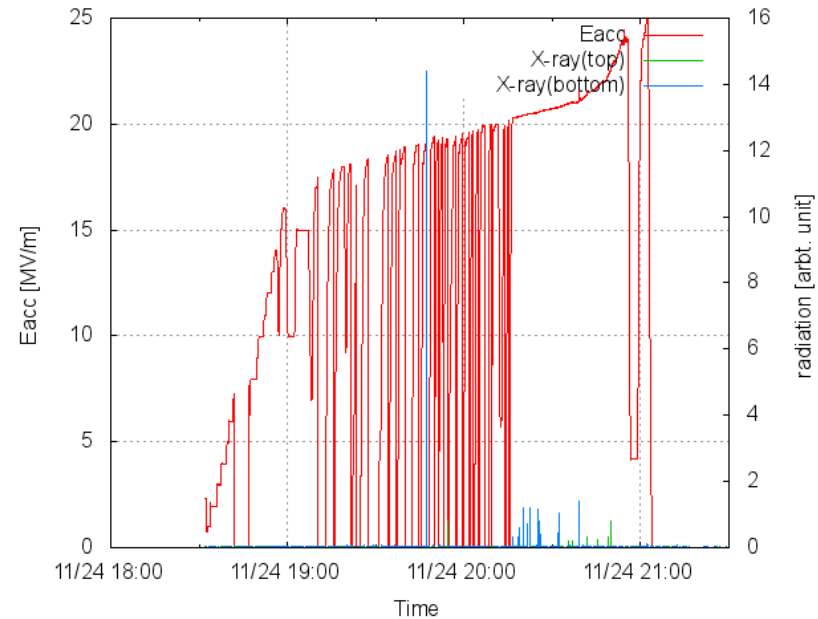
2K π -mode (initial)

- Measured at temperature of 1.6~2.1K
- Reached to 25 MV/m
- Multipacting from 18 to 23 MV/m, accompanied by X-rays.
- But they were processed. Radiation is also processed up to 24 MV/m.
- Radiation was very small, 20 μ SV/h at 25MV/m.

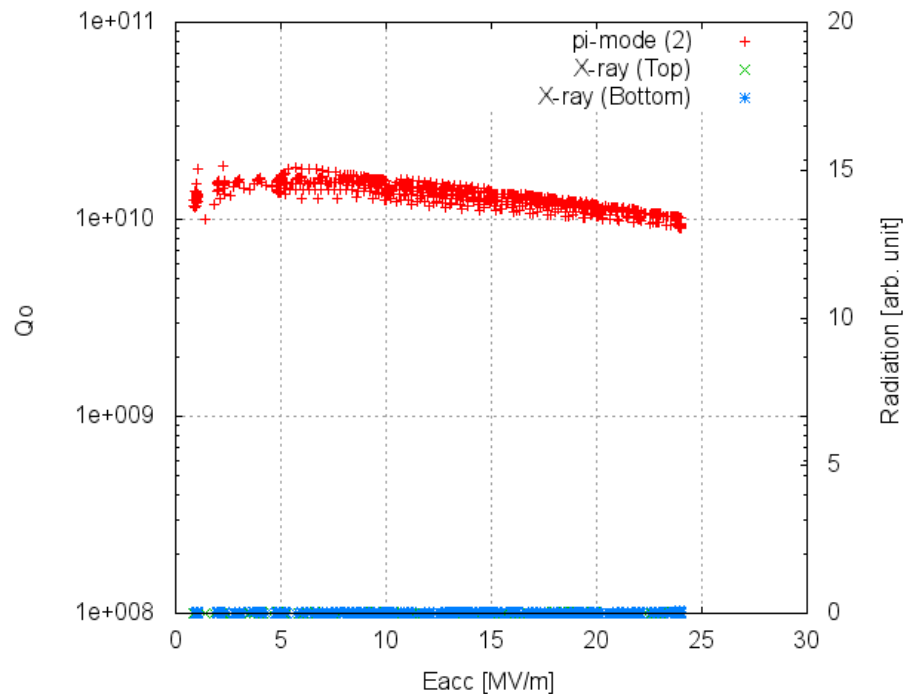
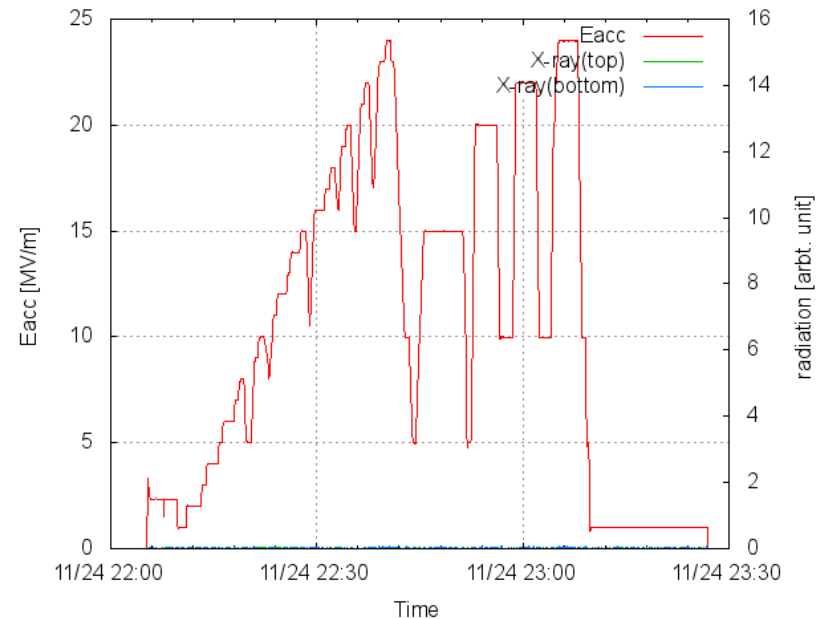
2K π -mode (final)

- Measured at temperature of $1.7 \sim 1.8$ K
- Reached to 24 MV/m, without quenches.
- X-ray on-set was 22 MV/m
- Radiation was very small, 4 μ SV/h at 24 MV/m.

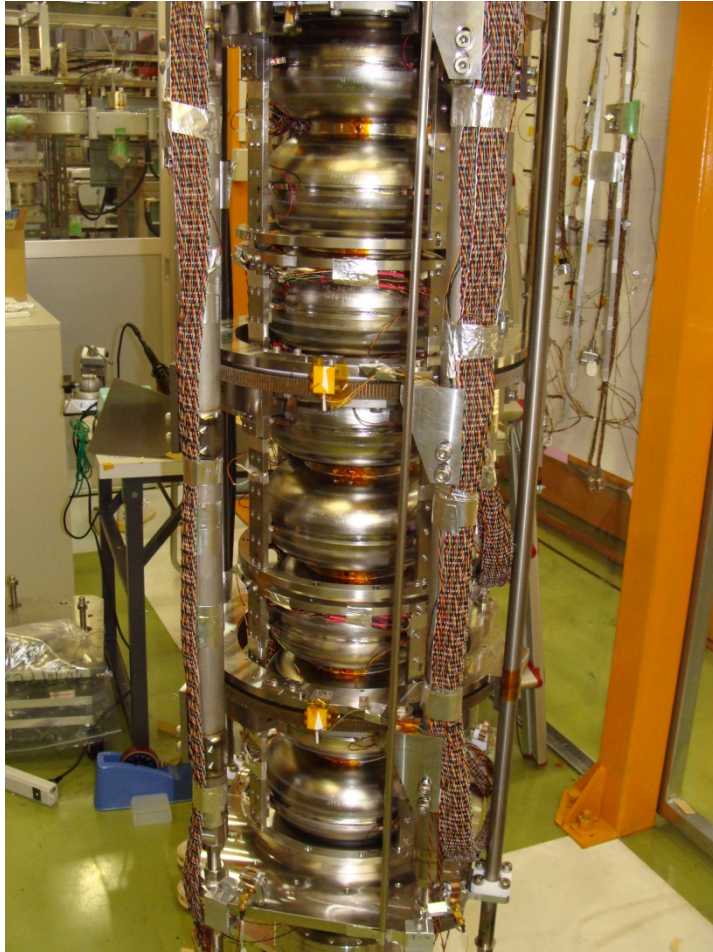
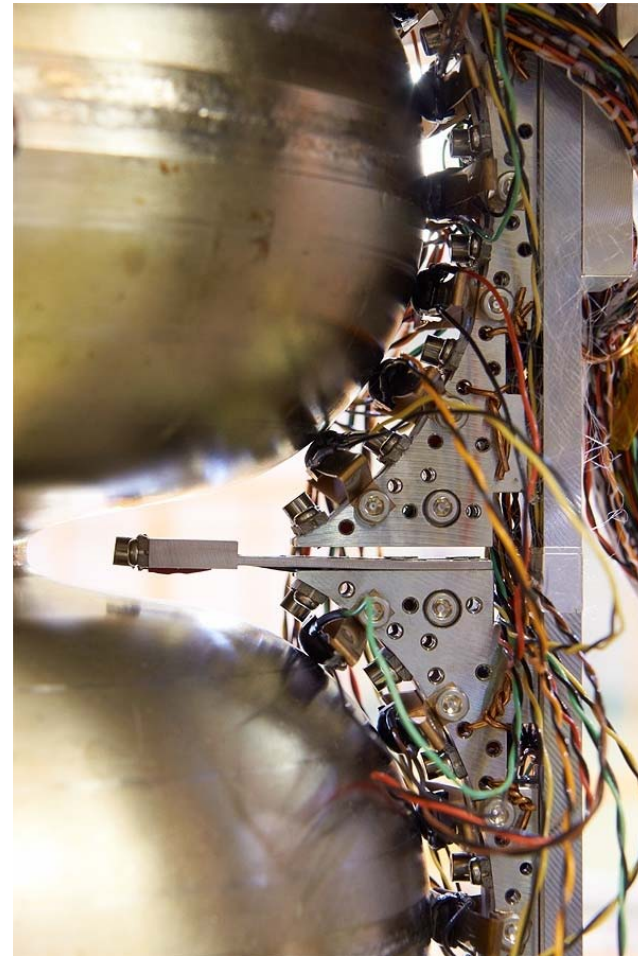
X-ray mapping system

- Array of **Si diode** for X-ray detection and **carbon resistor** for temperature measurement
- They will rotate around cavity by using pulse motor

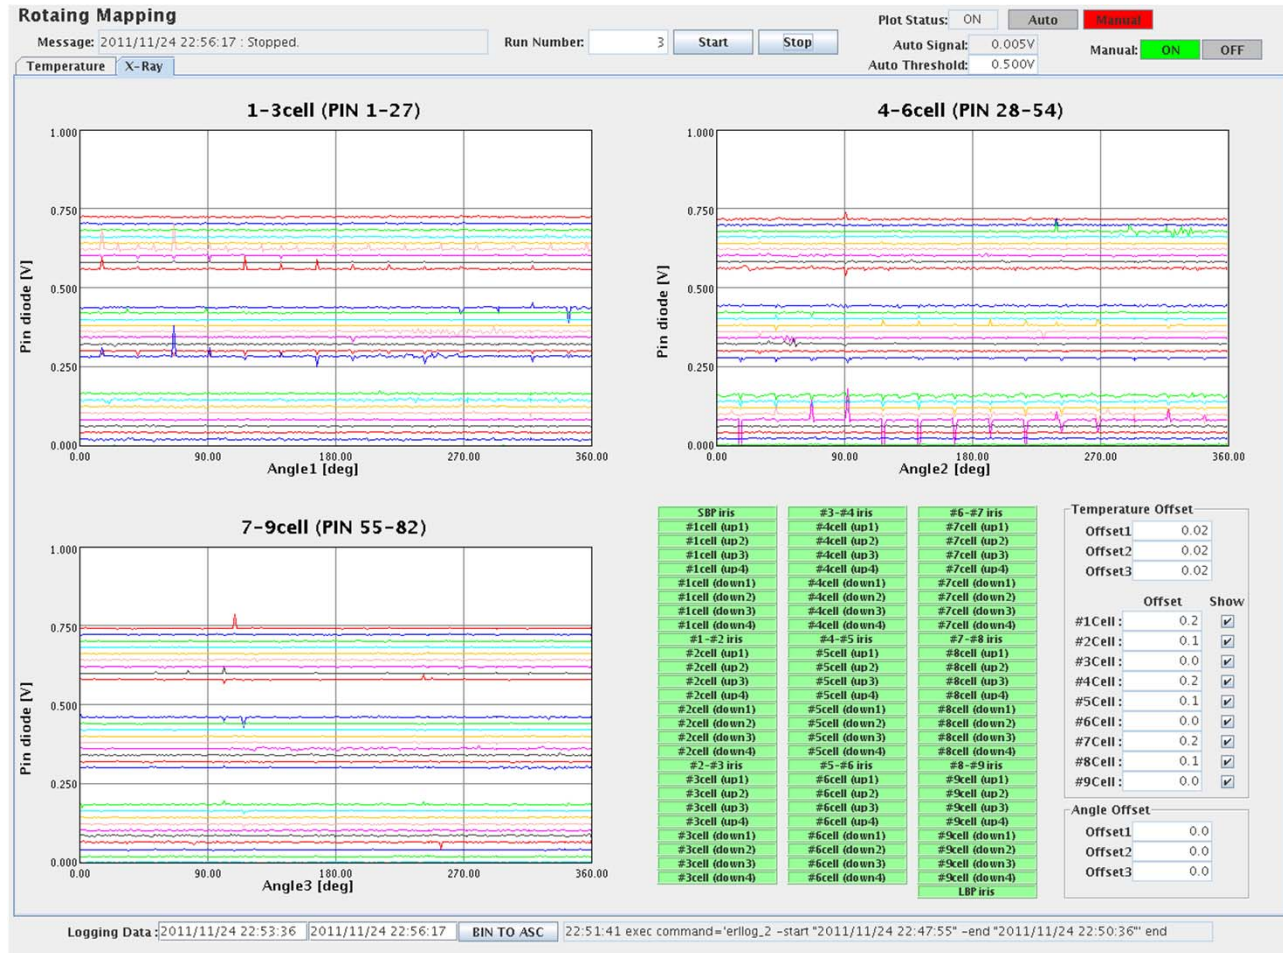
X-ray at 20 MV/m (final π -mode)

No X-rays were observed.
